HUD's Office of Multifamily Housing Needs To Improve Its Oversight of PBRA and FHA- Insured PBV Properties Converted Under RAD

Audit Report Number: 2025-CH-0001

December 18, 2024

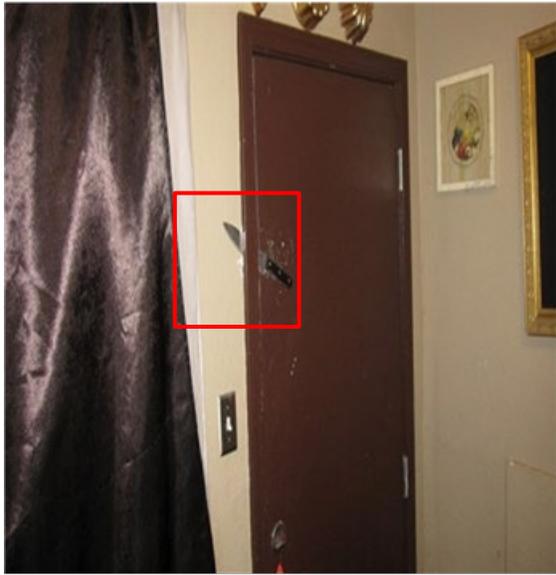
Picture 1 – Doors (NLT): Property ID 5129; damaged frame with knife wedged into doorframe for security.

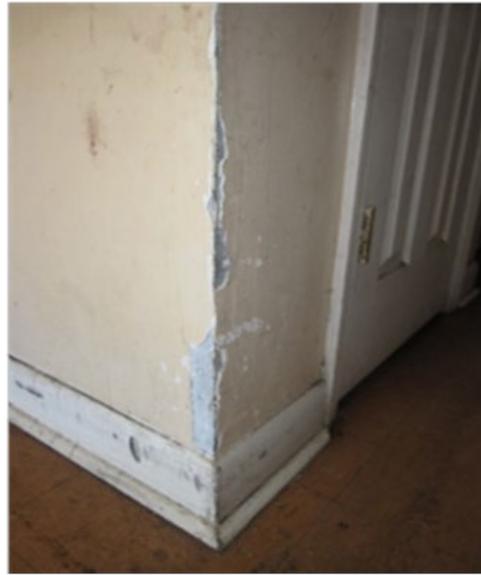
Picture 2 – Walls (non-HS): Property ID 1435; damaged wall in living room, chipped corner, and missing paint.

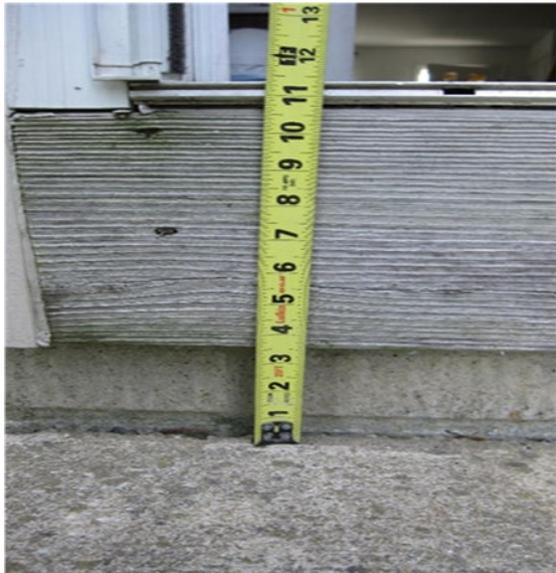
Picture 3 – Other hazard (NLT): Property ID 6978; high entryway step with approximate 11-inch rise, elderly occupant uses a walker, poses a falling hazard.

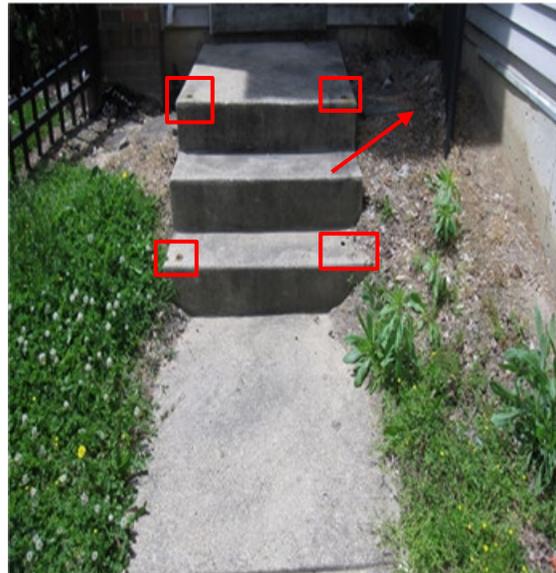
Picture 4 – Other hazard (NLT): Property ID 6978; railings not connected, set to the side, causing possible falling hazard on entry steps.

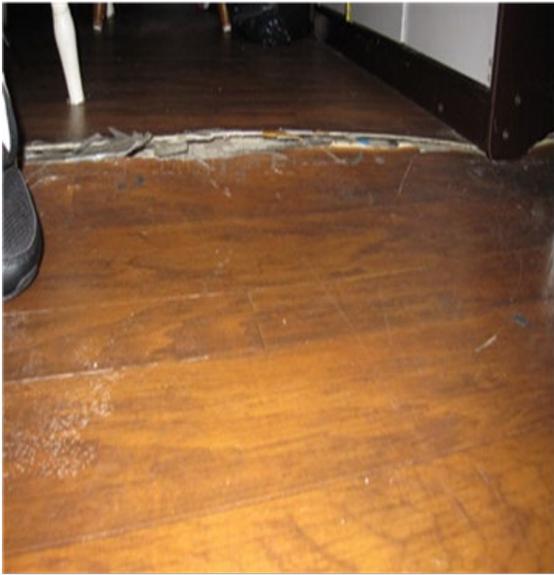
Picture 5 – Floors (non-HS): Property ID 6978; tears in basement flooring, partially covered with tape, tripping hazard.

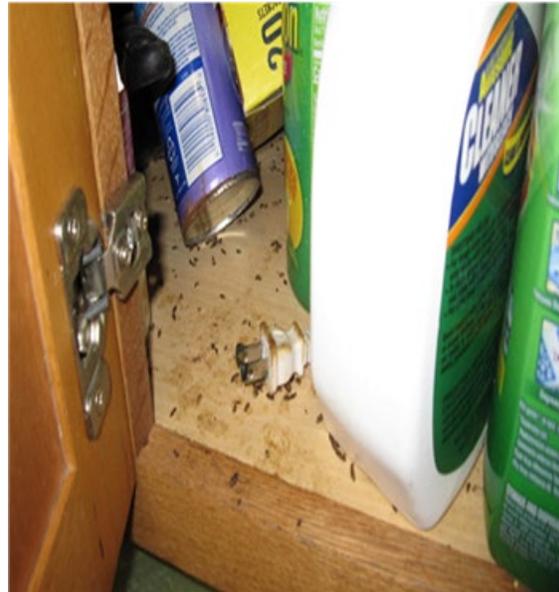
Picture 6 – Infestation (NLT): Property ID 6438; rodent droppings under kitchen sink.

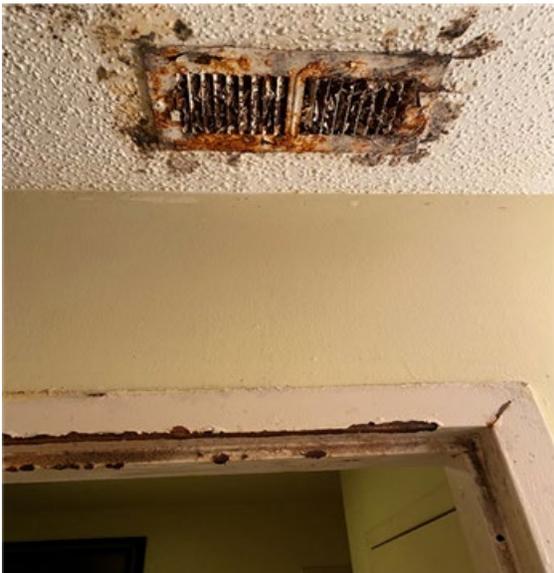
Picture 7 – Hazard (NLT): Property ID 3812; rusted ceiling vent in bathroom, water damage, and possible mold or mildew on ceiling.

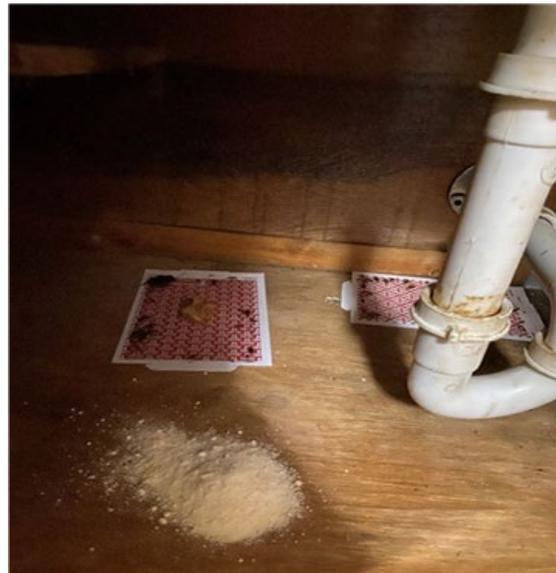
Picture 8: - Infestation (NLT): Property ID 3812; insect traps with dead insects under kitchen sink.

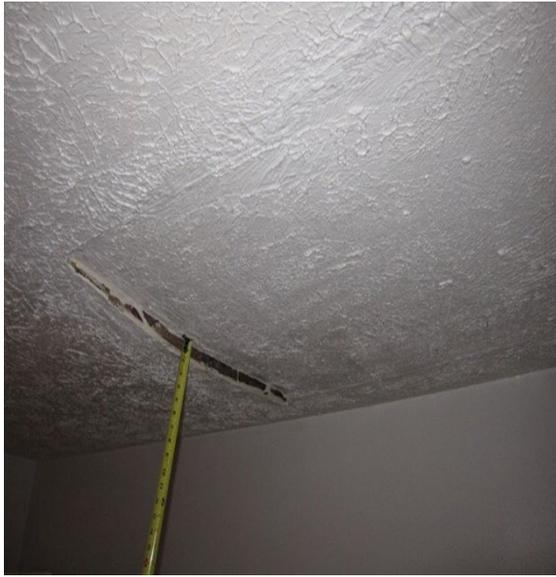
Picture 9 – Ceiling (non-HS): Property ID 2652; cracked and bulging ceiling above a child's bed.

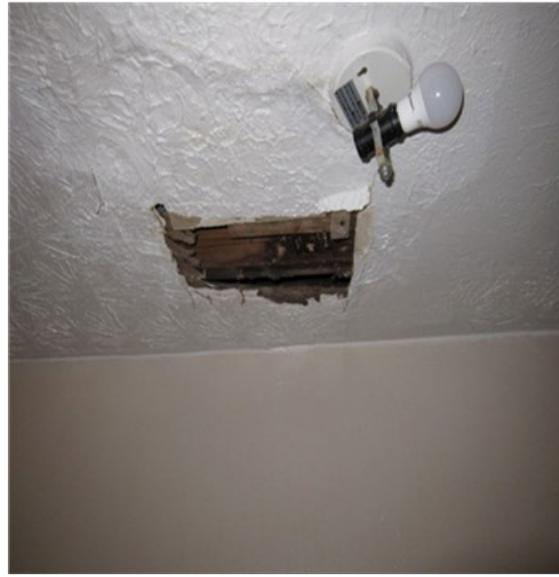
Picture 10 – Ceiling (non-HS): Property ID 1435; hole in kitchen ceiling.

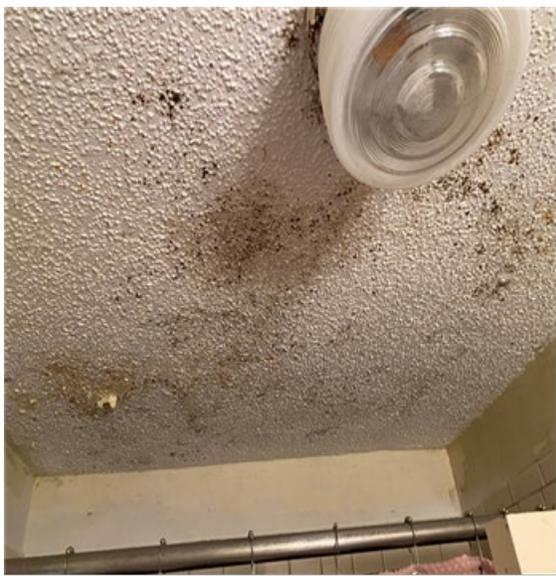
Picture 11 – Ceiling (non-HS): Property ID 3812; water stains, water damage, and possible mildew or mold on bathroom ceiling.

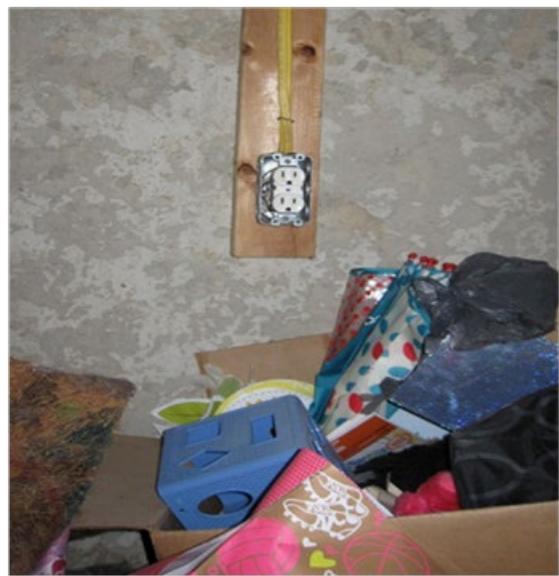
Picture 12 – Electrical (LT): Property ID 6978; missing outlet cover in basement, exposing interior of outlet box.

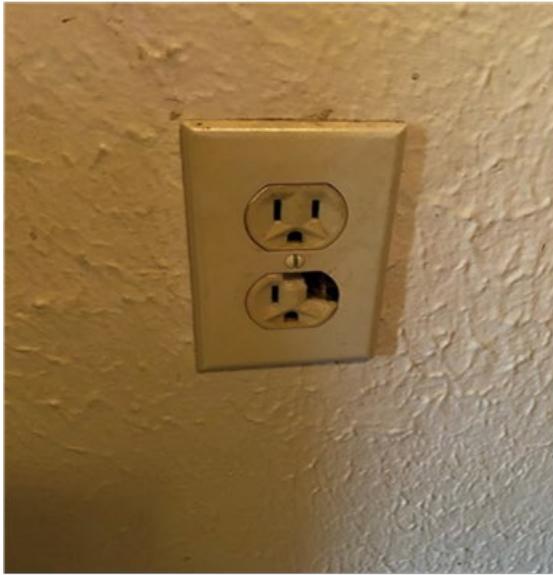
Picture 13 – Electrical (LT): Property ID 3812; broken outlet cover plate where electrical plug is inserted, in bedroom.

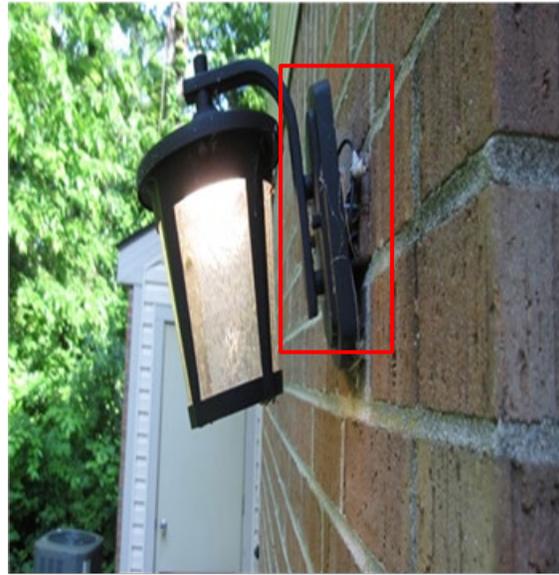
Picture 14 – Electrical (non-HS): Property ID 6438; exposed, frayed electrical wires on exterior light fixture, and light fixture is not secured.

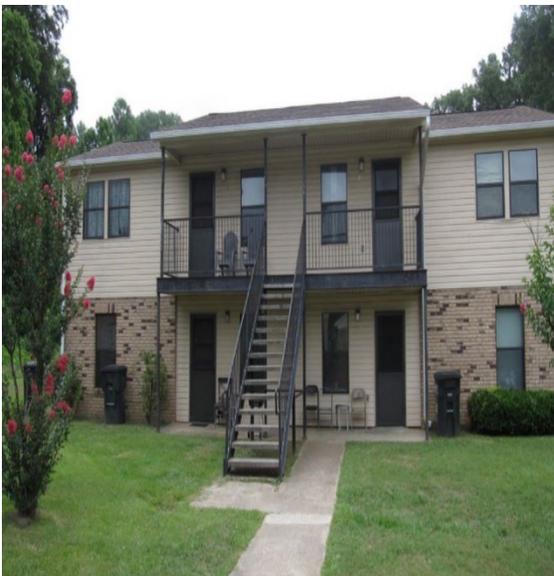
Picture 15 – Two-story building showing stairs to second floor.

Pictures 15 through 20 – Patio-porch-balcony and stairs (non-HS): Property ID 5129; baluster and handrail to second story unit damaged; baluster and handrails not secured at bottom due to damaged concrete and not secured at the top due to missing screws, causing falling hazard.

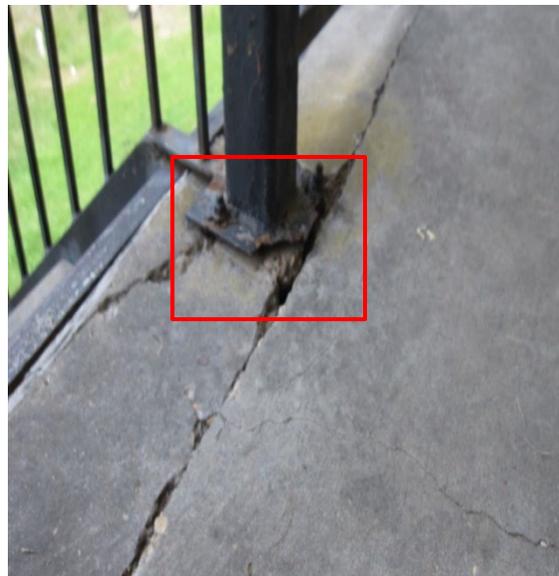
Picture 16 – Crumbling and cracked concrete and rusted and damaged base with missing screws.

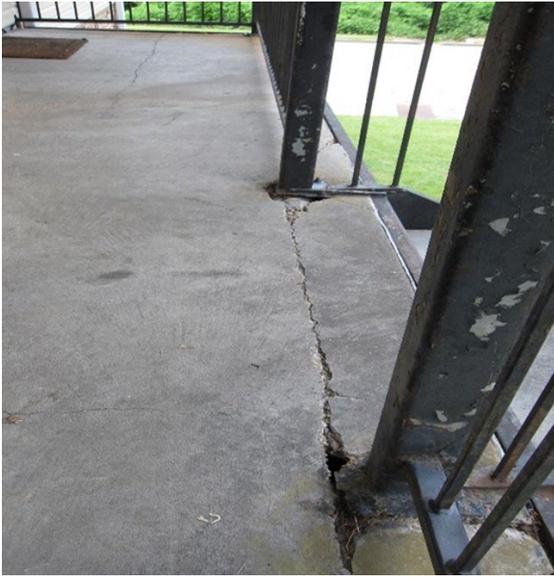
Picture 17 – Alternate view of crumbling and cracked concrete at the railing base.

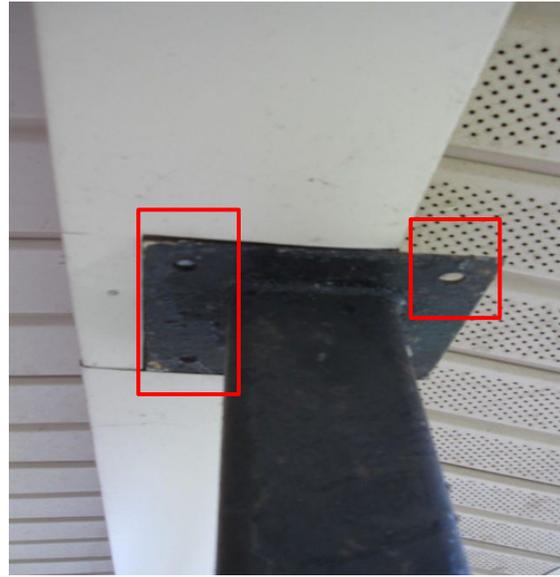
Picture 18 – Top of railing off center and missing all screws.

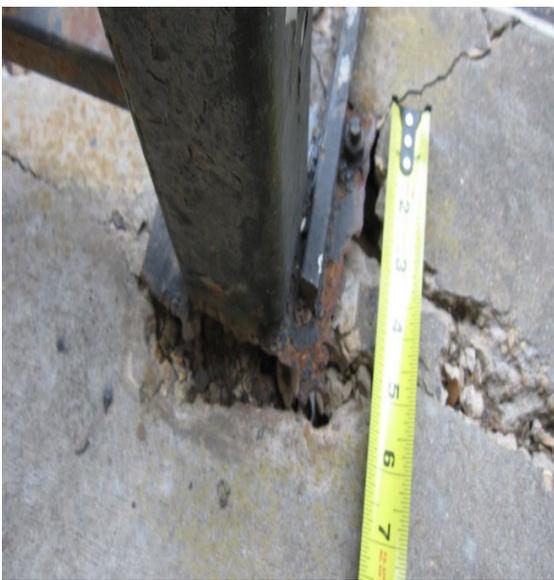
Picture 19 – Crumbling concrete with rusted base showing screws missing or not connected.

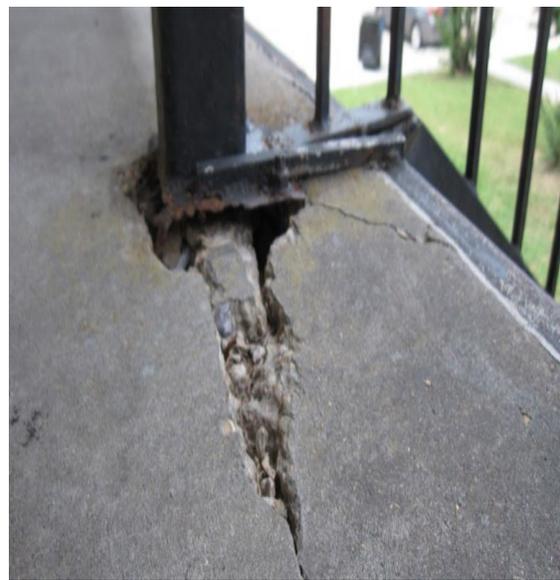
Picture 20 – Alternate view of base with missing and crumbling concrete showing missing screws.
