BLM Companies LLC, Hurricane, UT

Single-Family Real Estate-Owned Management and Marketing III Program Field Service Area 4P

**Audit Report Number: 2017-CH-1011
September 30, 2017**

Subject: BLM Companies LLC, Hurricane, UT, Did Not Provide Property Preservation and Protection Services in Accordance With Its Contract With HUD and Its Own Requirements

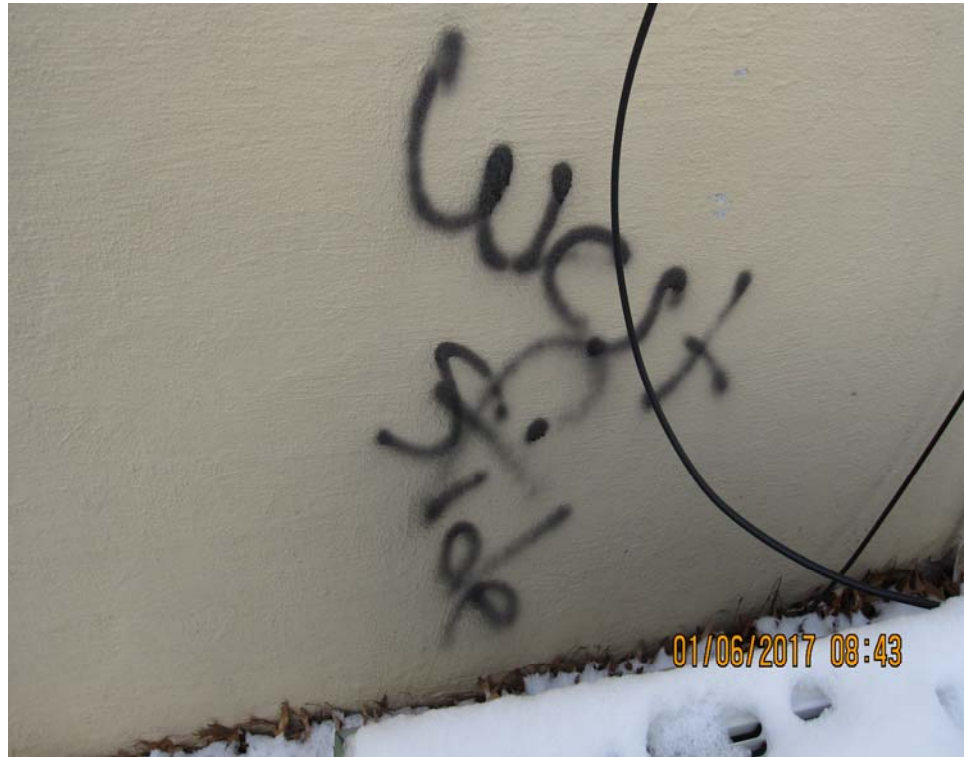
Property RI89:
exterior graffiti on back
of property

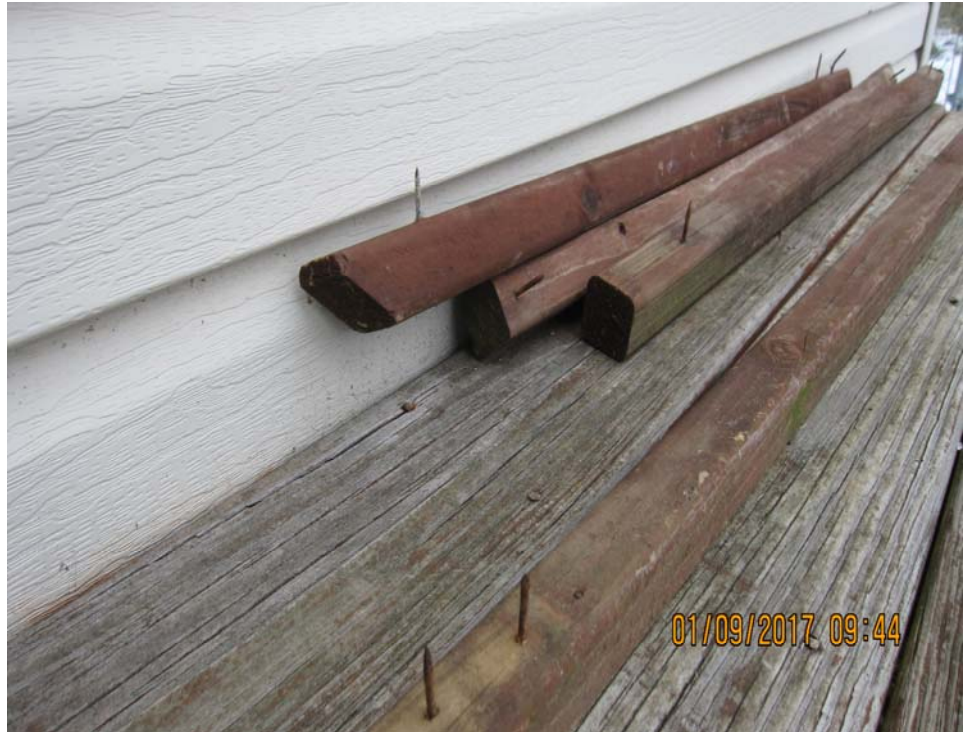
Property RI95:
balusters with nails on
deck

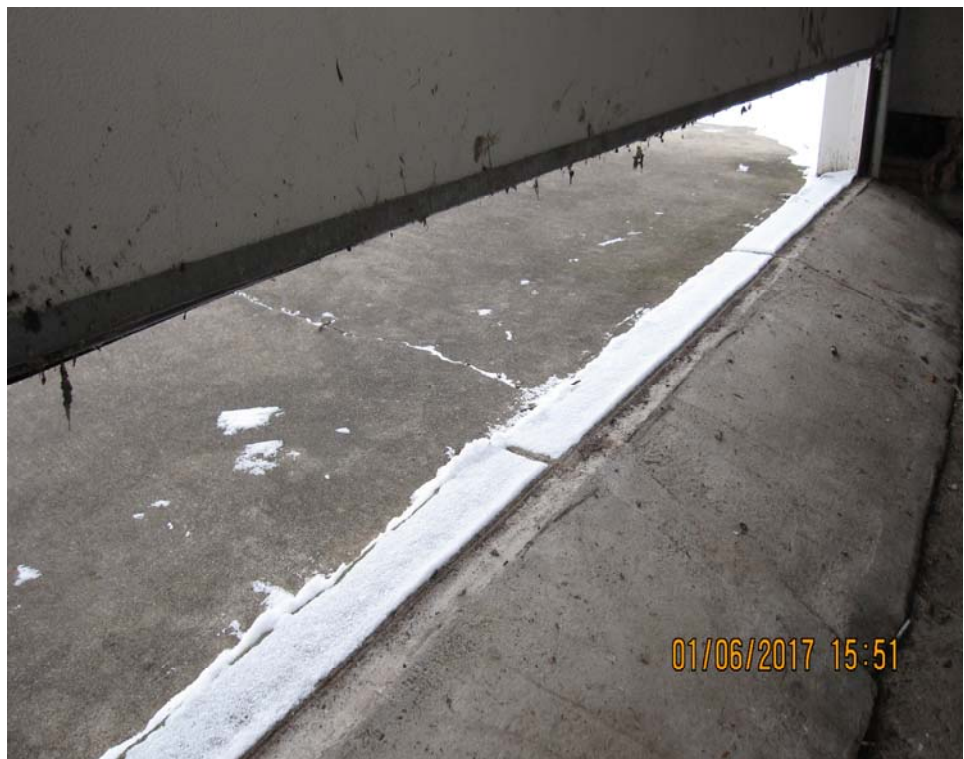
Property RI93:
unsecured garage

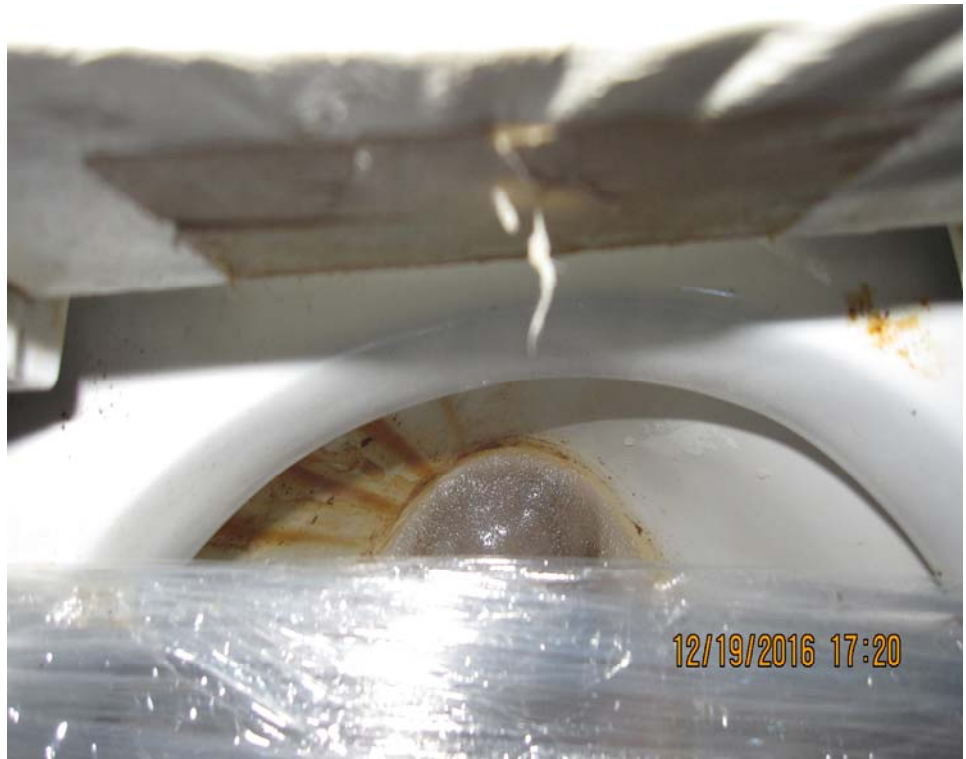
Property RI48:
toilet not winterized

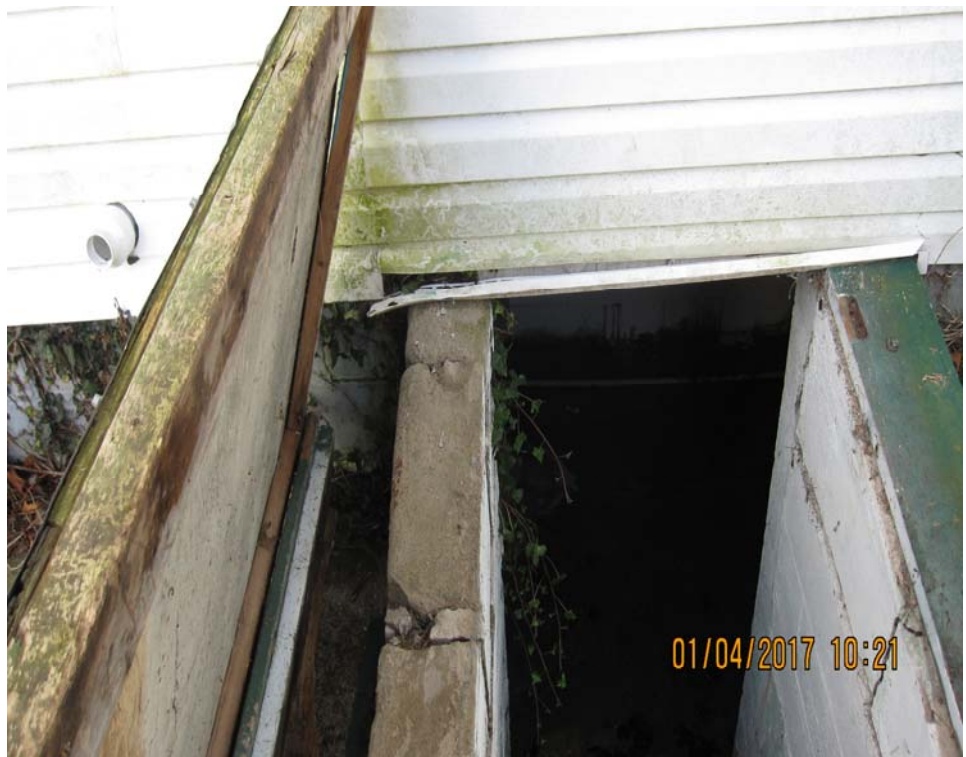
Property RI79:
unsecured removable
door to cellar

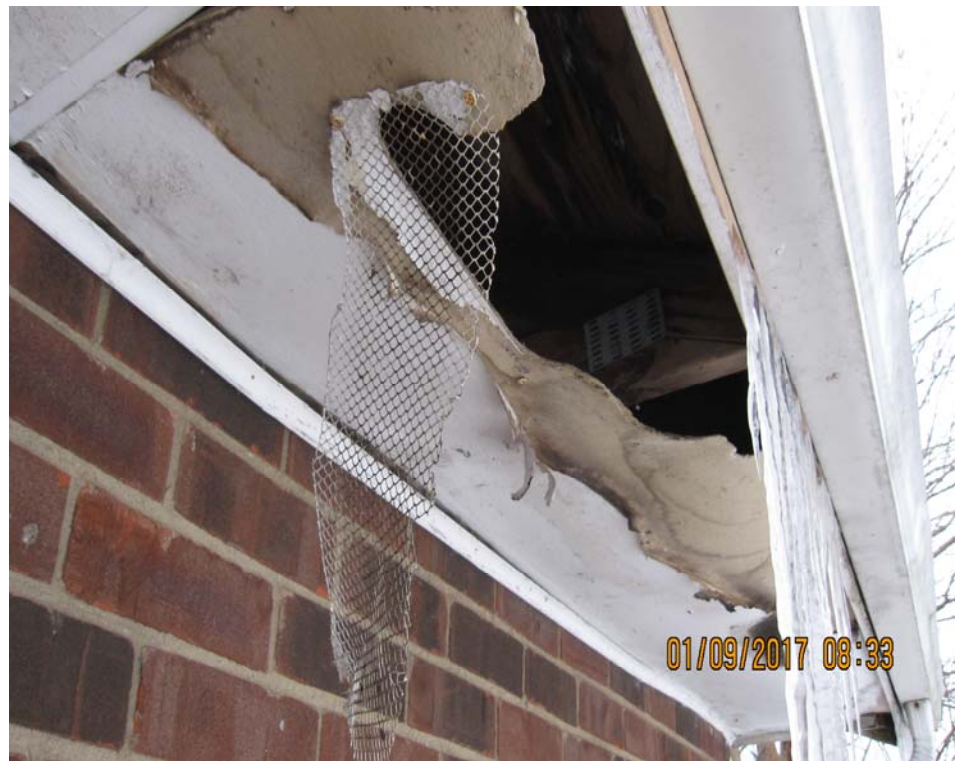
Property RI94:
deteriorated rear soffit

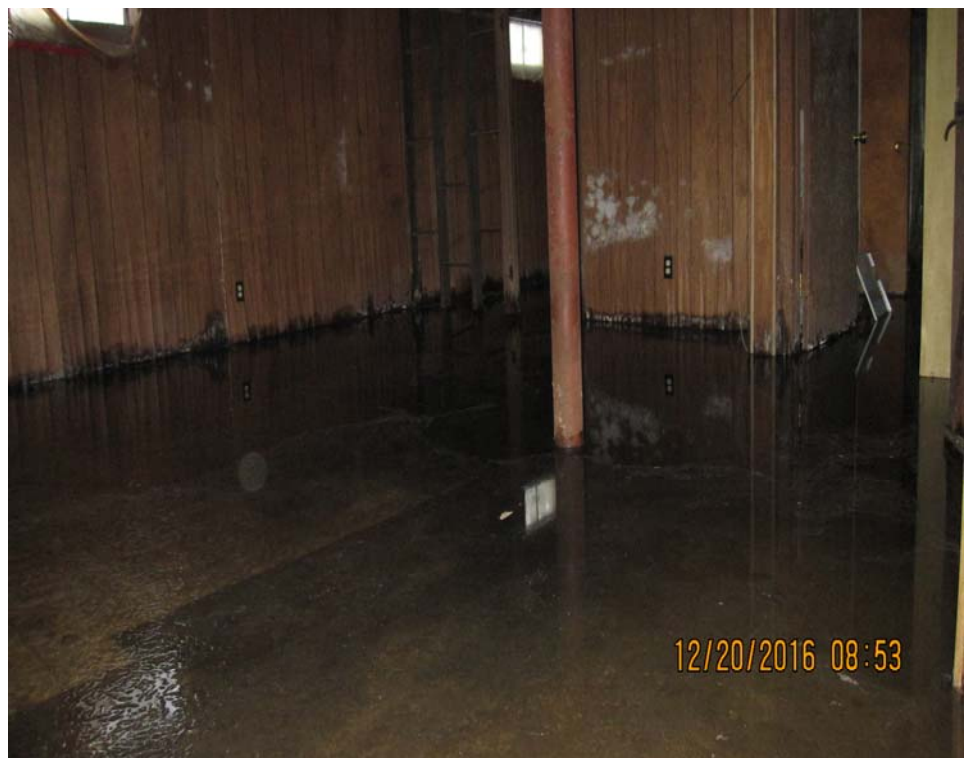
Property RI50:
flooded basement

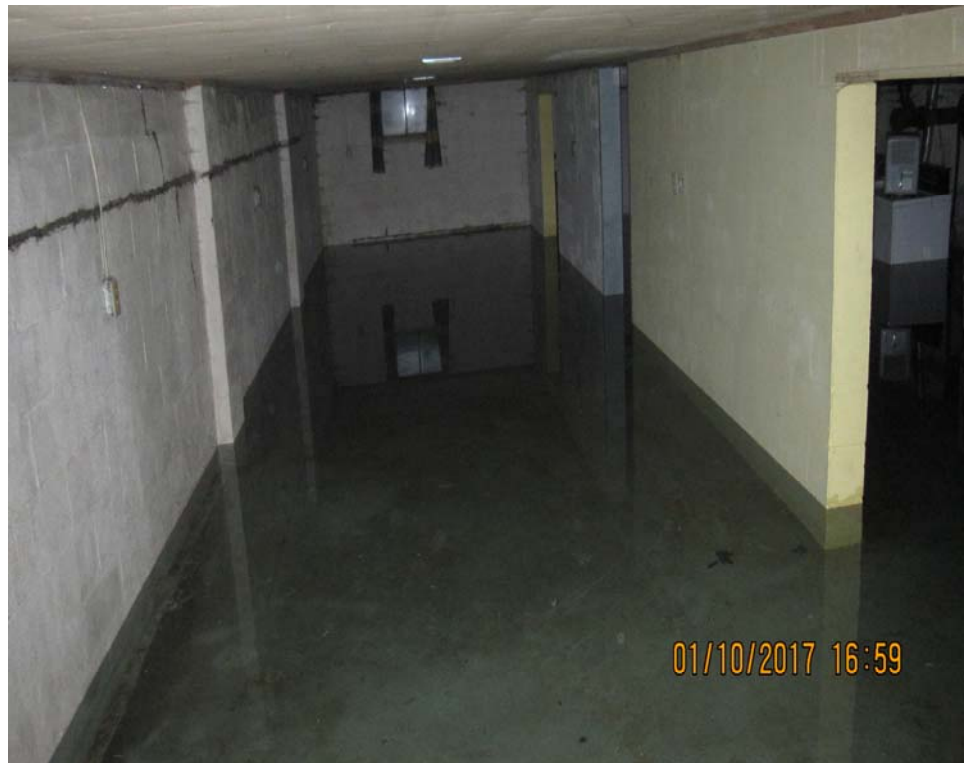
Property RI104:
flooded basement.

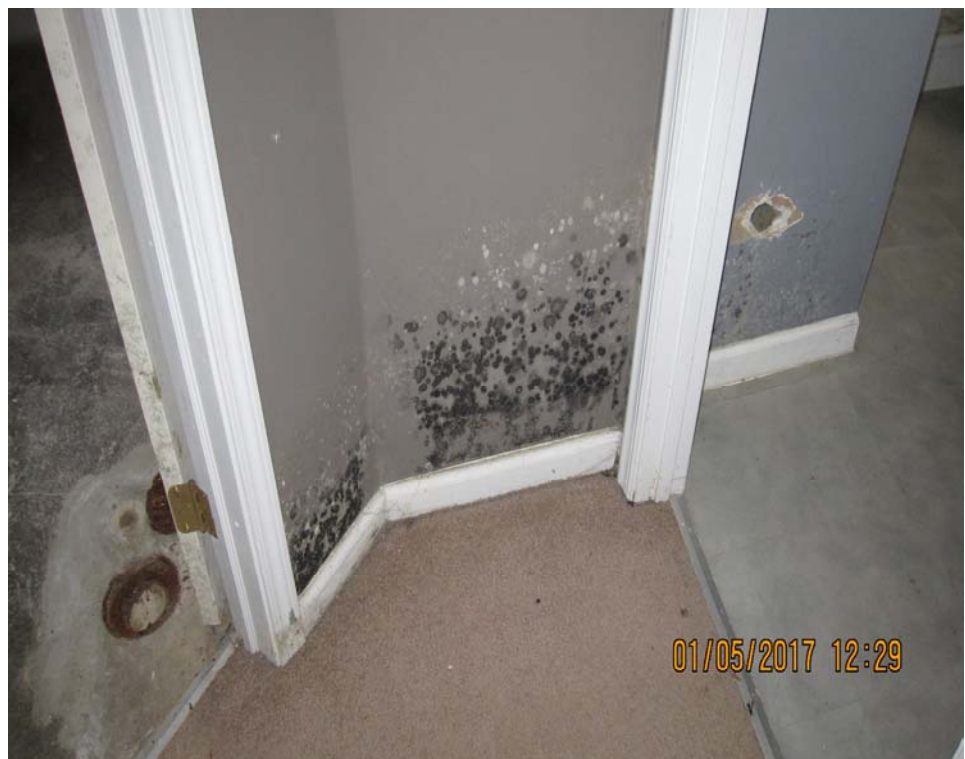
Property RI86:
unmitigated mold in
basement

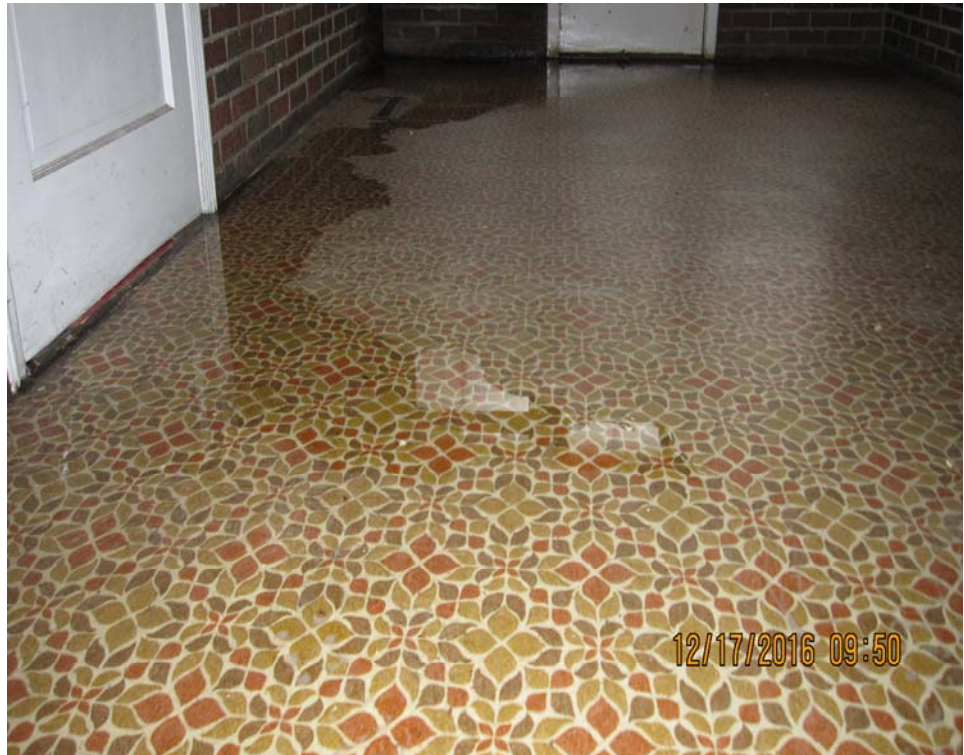
Property RI36:
standing water between
garage and kitchen

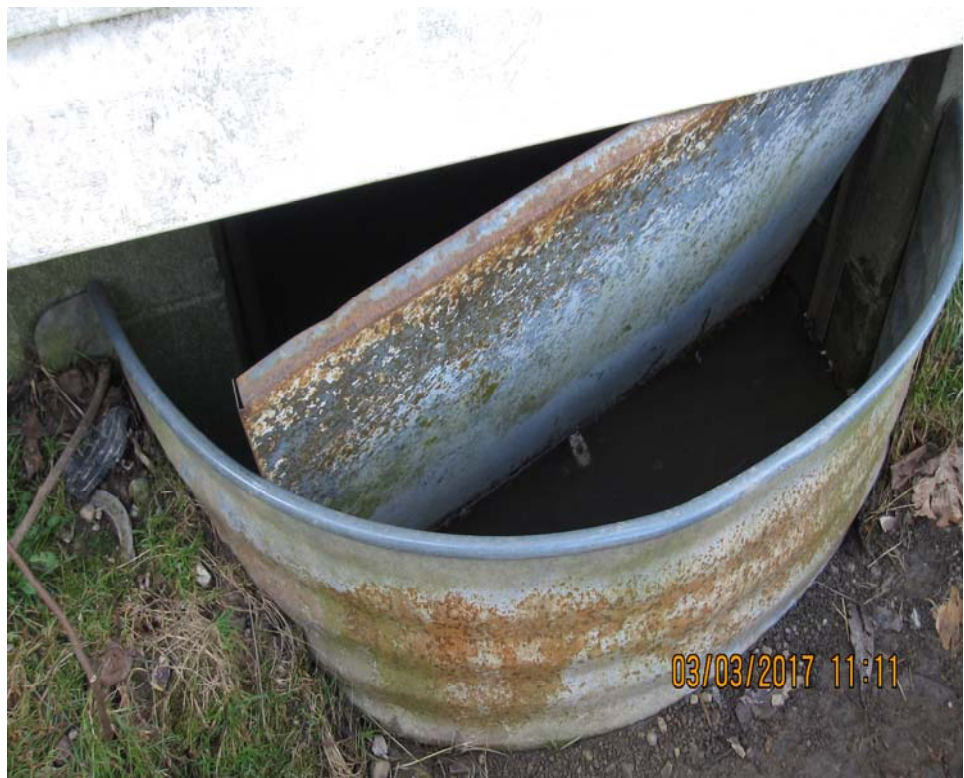
Property IS26:
flooded crawlspace

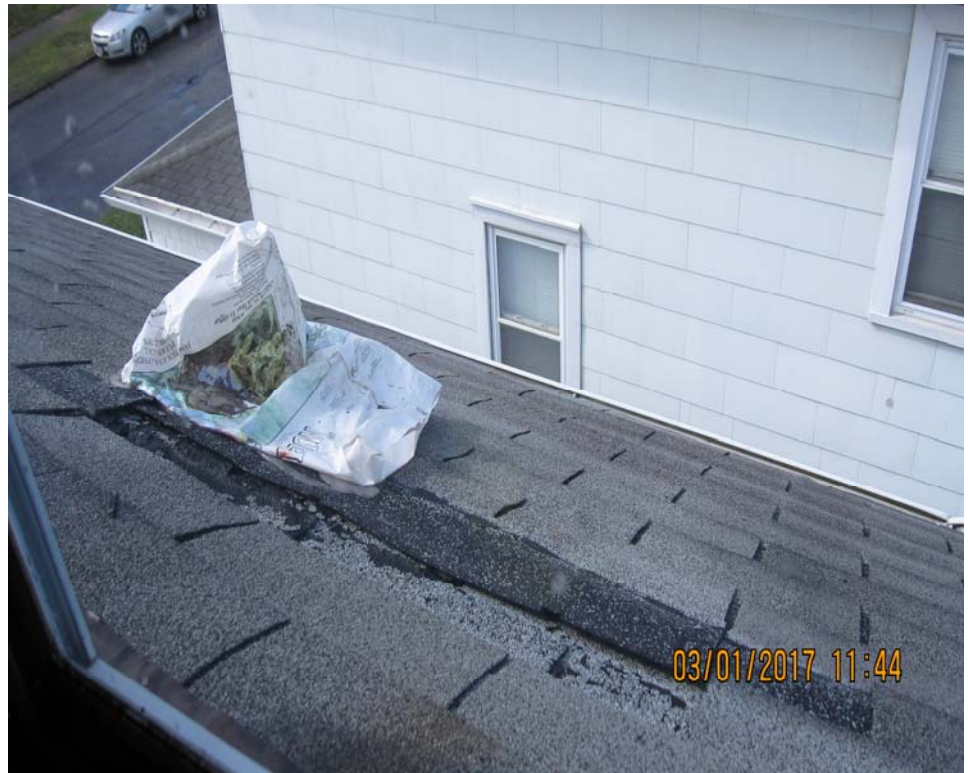
Property IS16:
hole in roof covered by
plastic bag – allowed
water intrusion

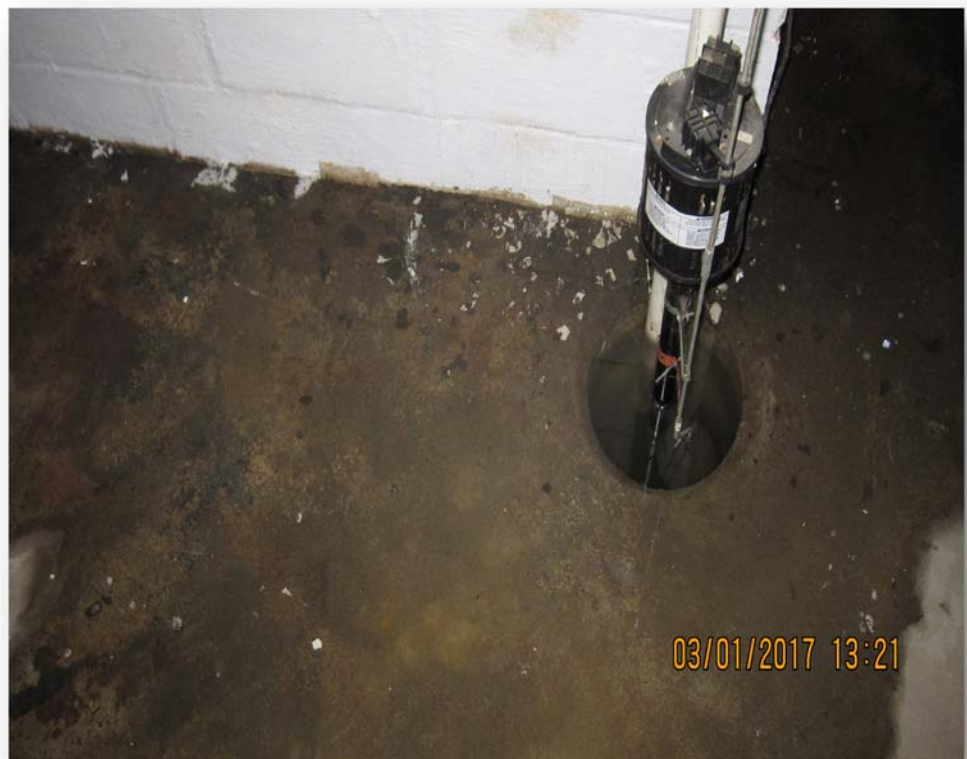
Property IS17:
malfunctioning
sump pump

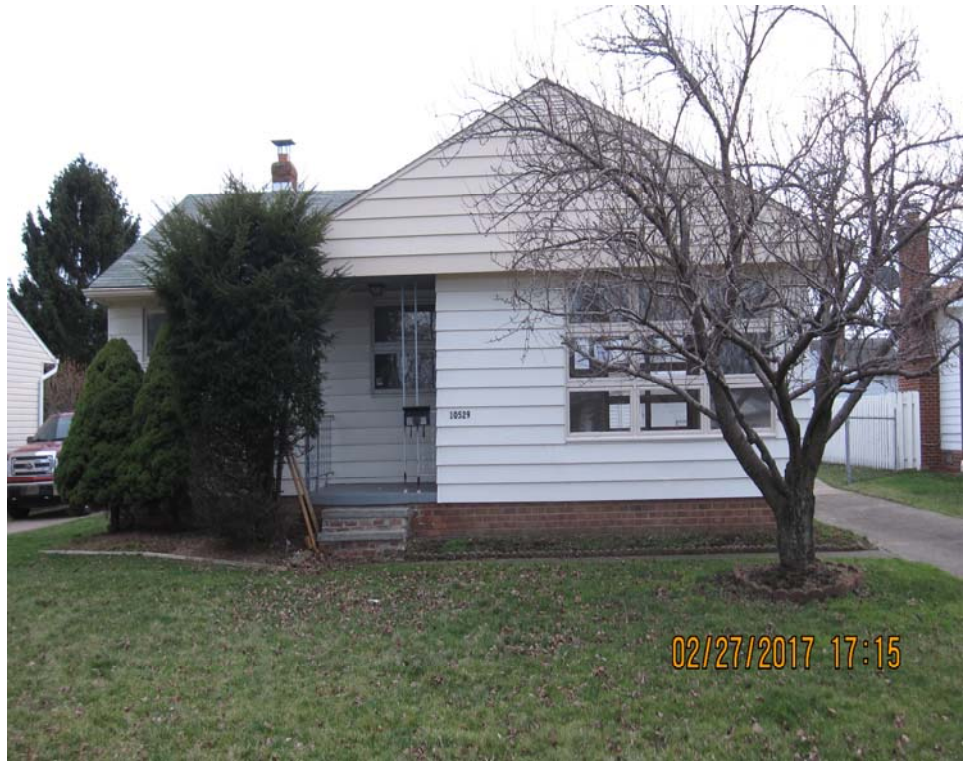
Property IS6:
faulty handrail on front
porch

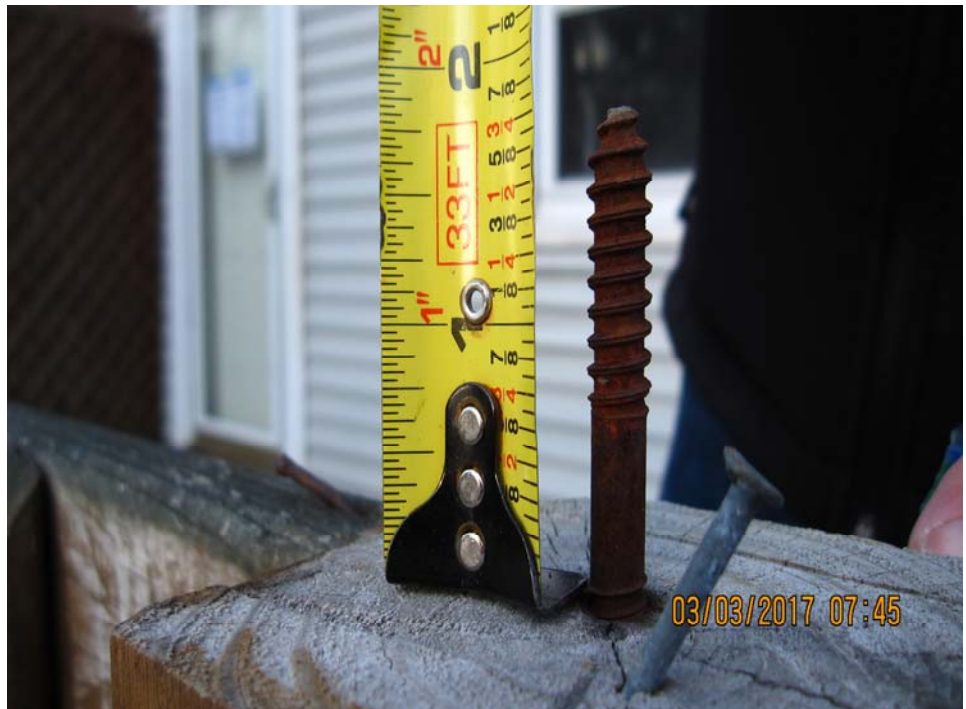
Property IS24:
exposed screw
and nail on rear deck

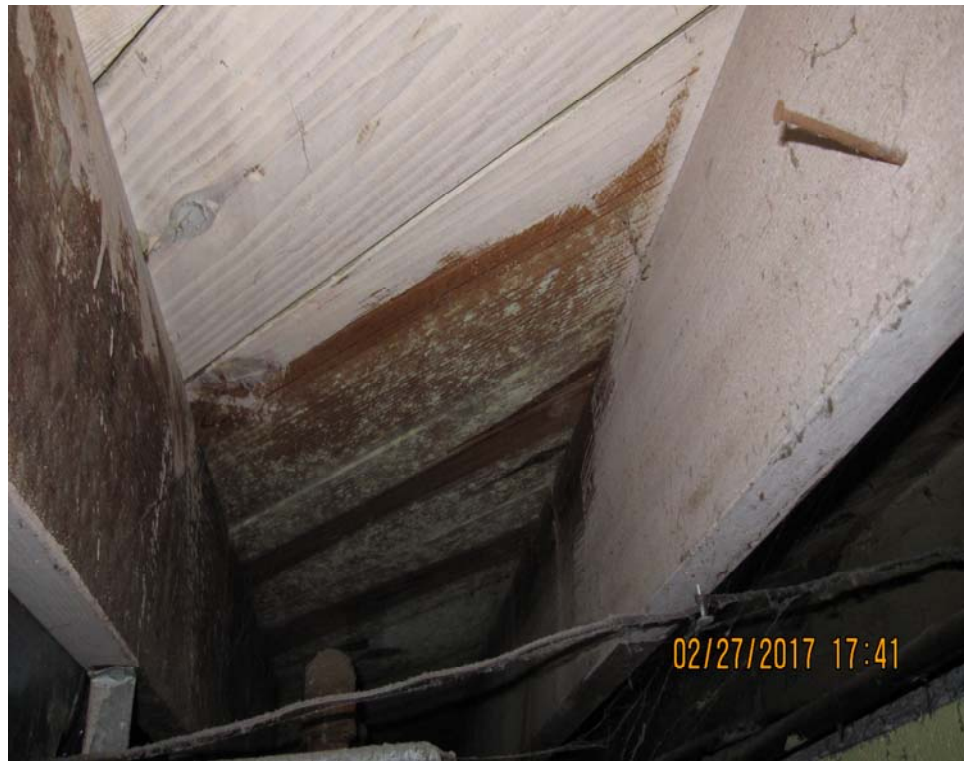
Property IS6:
unmitigated mold in
basement joists and
subfloor

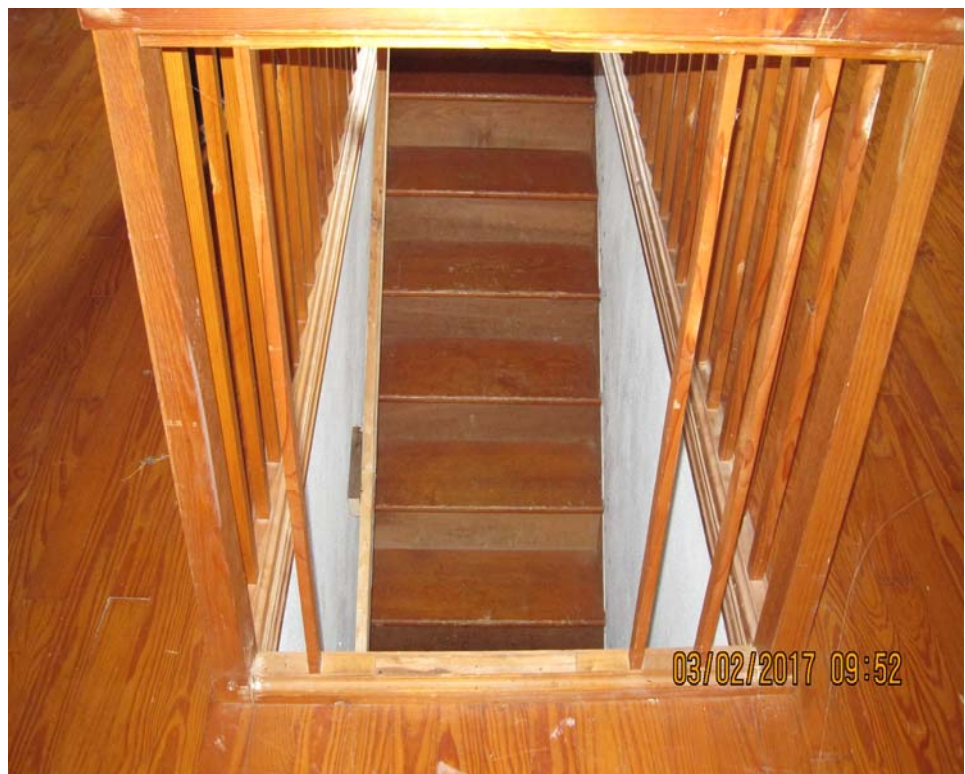
Property IS19:
missing balusters in
upstairs bedroom

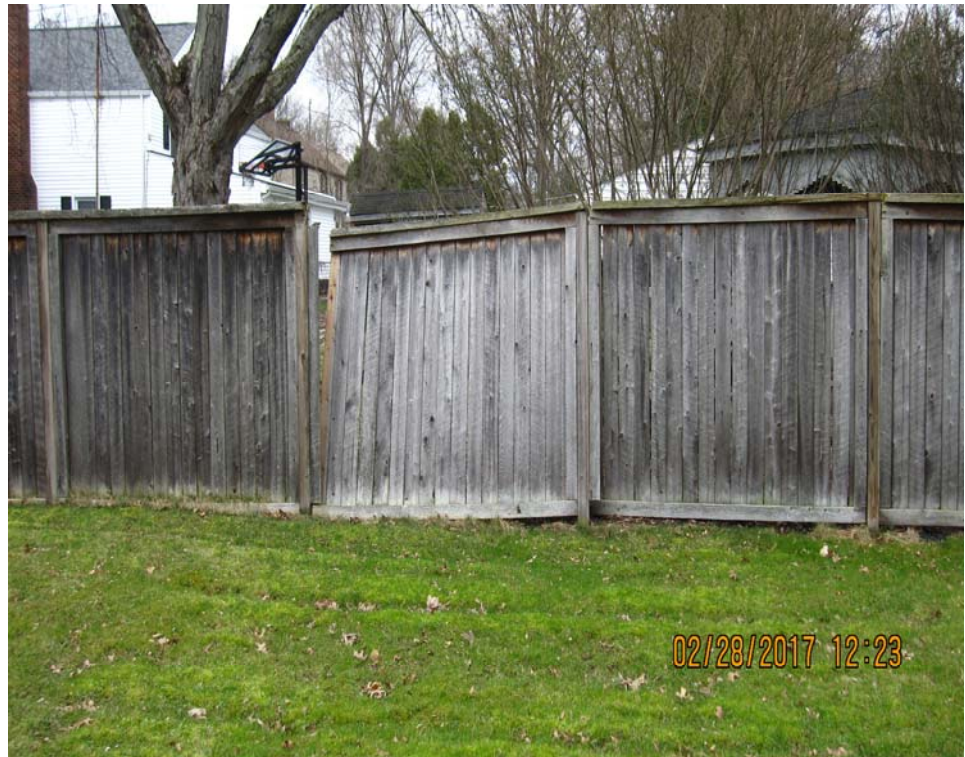
Property IS9:
broken-falling fence

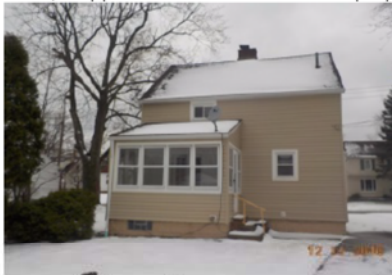
- o Unmarked tripping hazard at first step in house.
 - There was a ripped piece of carpeting on the first step of the stairway inside of the front door leading up to the second floor of the house.
 - BLM Response: Trip hazard should have been addressed. The responsible vendor has been put on notice of the issue, has been (or will be) provided updated training on the correct procedures, and has committed to improving its future performance.
- o Handrail not secured (at steps in exterior in the rear of house)
 - Handrail at rear of the house was not stable and could be moved with little force. The picture shows that the first post is not perpendicular to the ground.
 - BLM Response: A post not being perpendicular does not necessarily deem a handrail not secured. While handrail can move with a little force, it appears that it would serve its purpose to provide support.

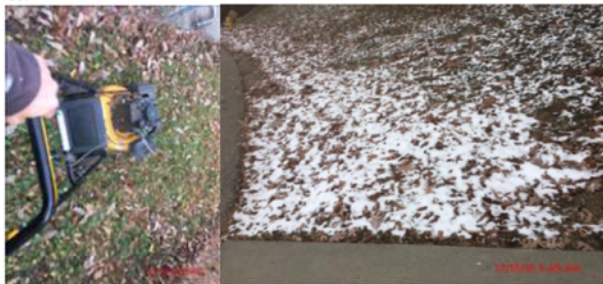
- [REDACTED] (FHA case number 411-491088)
 - o Landscape issue – leaves in the yard
 - Leaves were evident throughout the yard, and the property was observed in the middle of December.

- BLM Response: Leaves were previously covered in snow and at times ice.
-

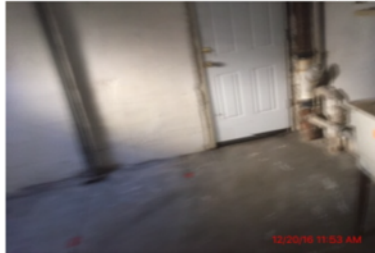
- Door frame for exterior door to basement not completely attached to the house
 - Exterior frame to rear of basement had large gap that allowed light and possibly elements and rodents into property.
 - BLMResponse: Gap appears to be new, either from weather or increased use. BLM should cover gap.

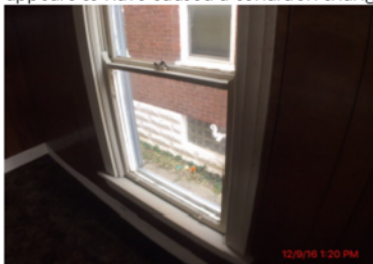
- Section of wall by trim contained phallic image.
 - BLM Response: Image should be painted over. The responsible vendor has been put on notice of the issue, has been (or will be) provided updated training on the correct procedures, and has committed to improving its future performance.

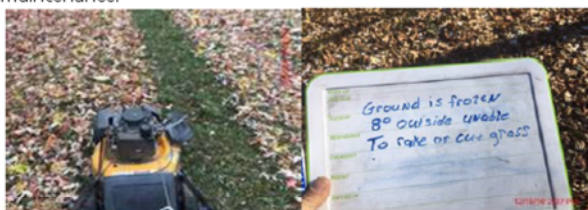
- OIG Inspection Date: 12/16/2016
- Landscape issue – leaves in the yard
 - BLM Response: Leaves were frozen to ground on previous yard maintenance.

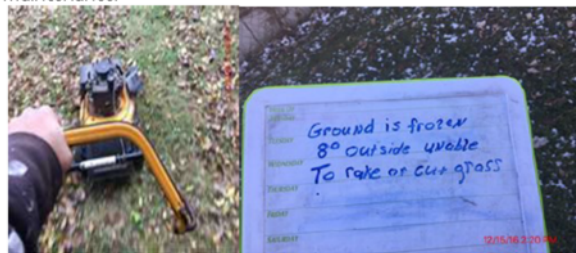
- OIG Inspection Date: 12/16/2016
- Landscape issue – leaves and debris in the yard/exterior of the property
 - Leaves were evident throughout back yard and were particularly thick close to the property.
 - BLM Response: Leaves were frozen to ground on previous yard maintenance.

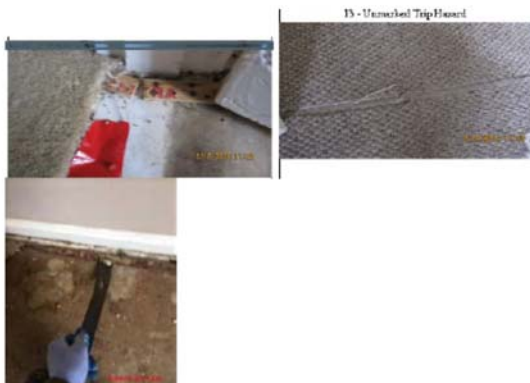
- Dirty carpeting
 - Carpeting was extensively stained throughout the home.
