Issue Date	September 30, 2007
------------	--------------------

Audit Report Number	2007-CH-1018
---------------------	--------------

SUBJECT: The City of Milwaukee, Wisconsin, Needs to Improve Existing Controls over Its HOME Program Regarding Housing Conditions and Contracting

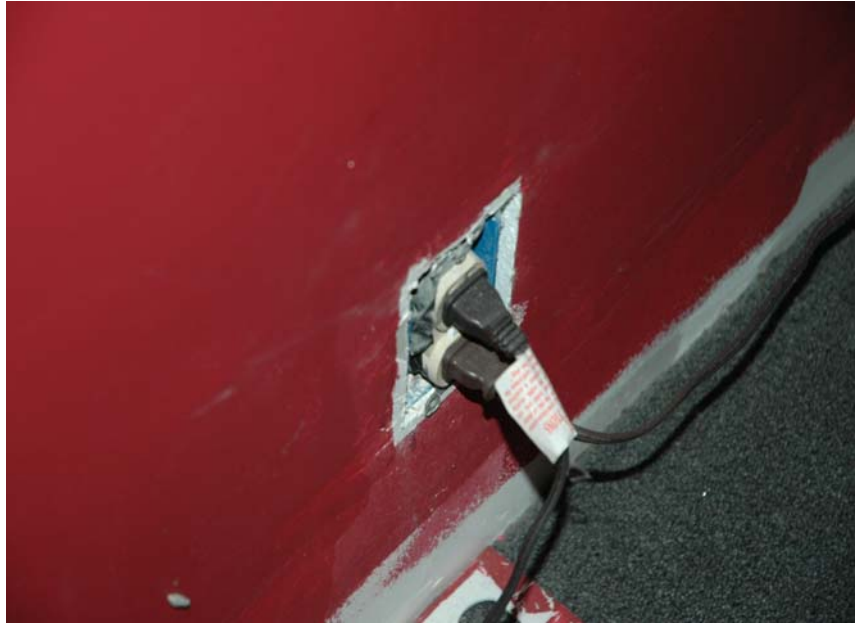
Project #7826: Outlet missing cover plate and exposing electrical contacts.

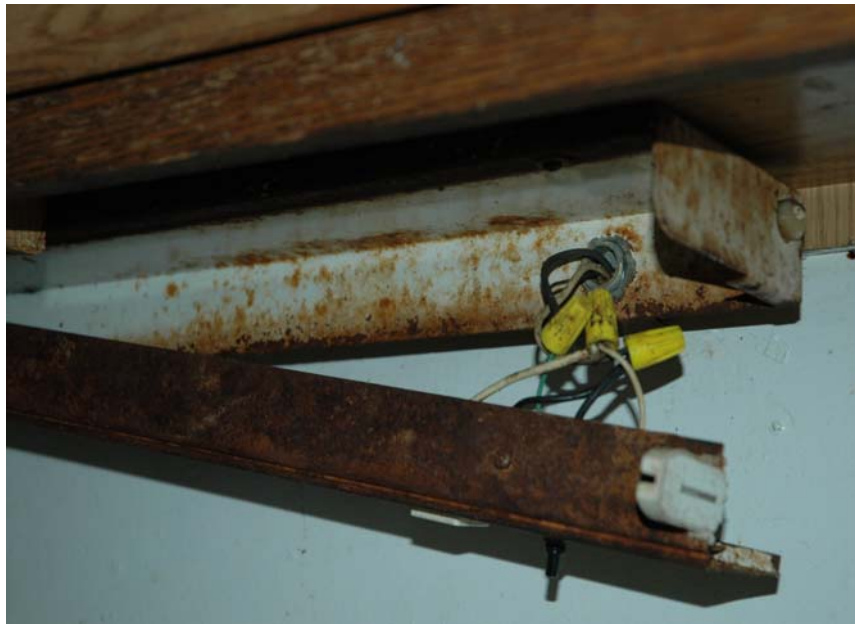
Project #8114: Light fixture hanging from wires exposing electrical contacts.

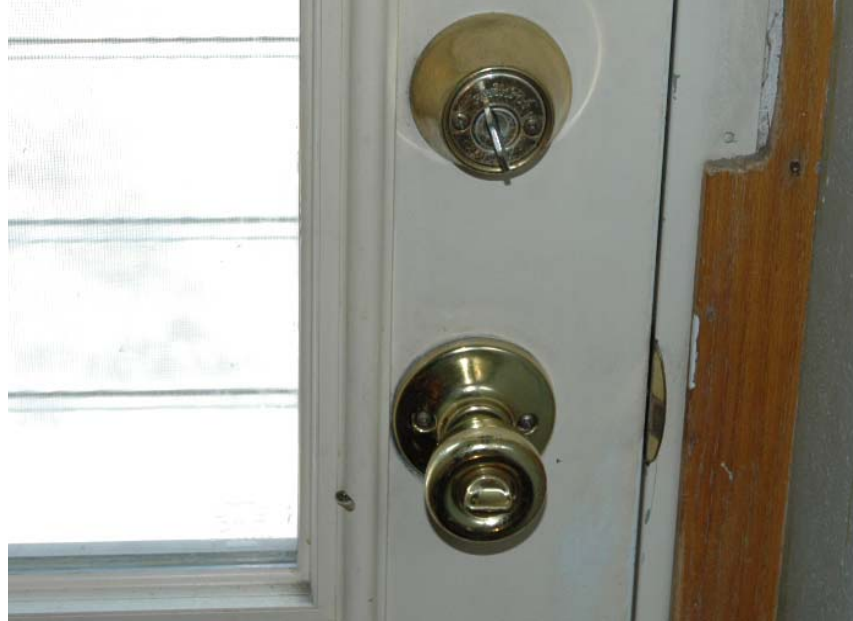
Project #8113: Kitchen door with keyed deadbolt lock on inside which can prevent egress.

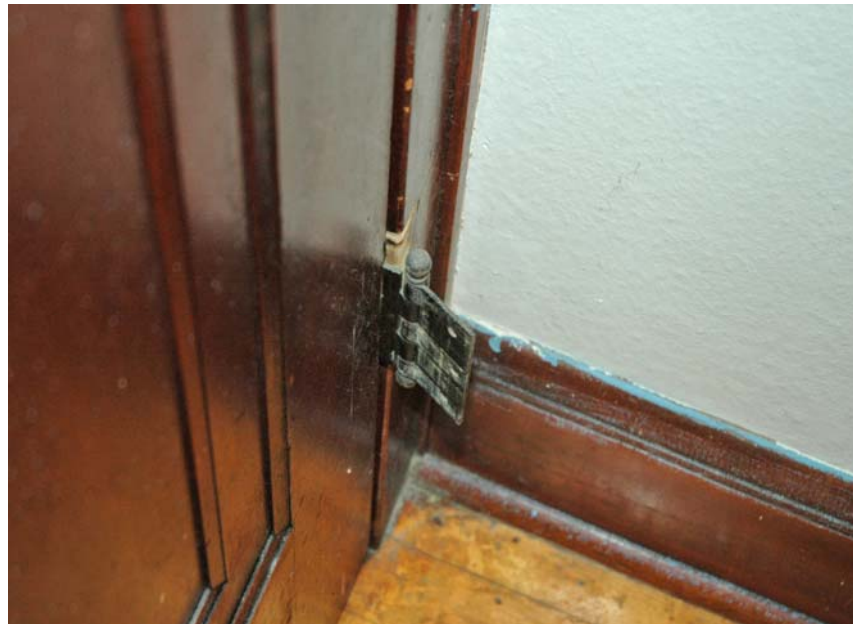
Project #7901: Detached bedroom closet door hinge.

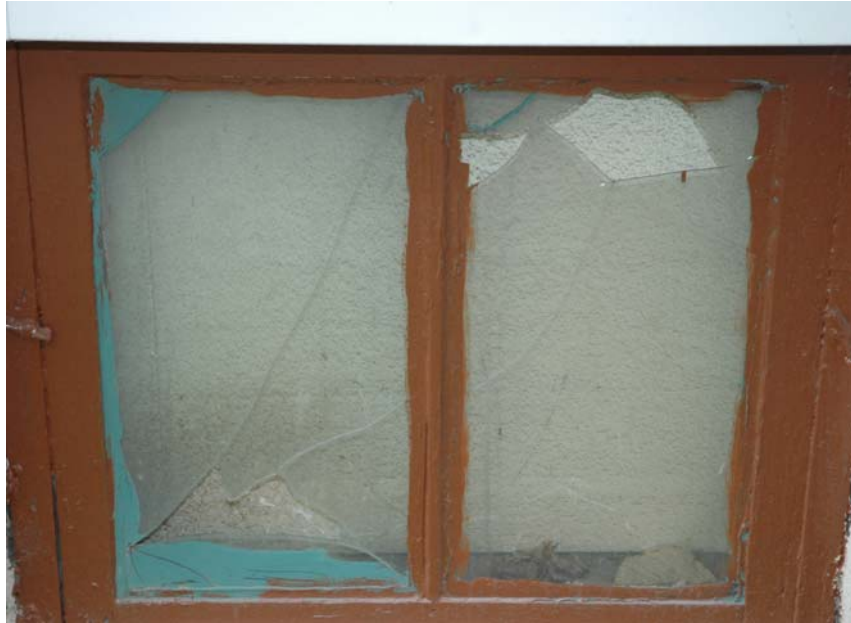
Project #8156: Broken glass panes on a basement window allowing moisture to enter and possible infestation. Household used towel to cover window.

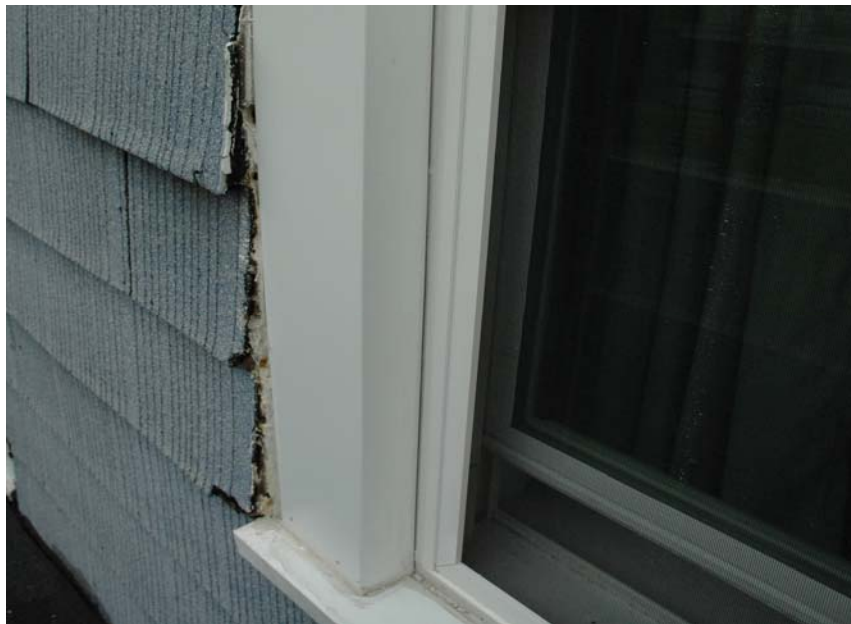
Project #8114: Newly installed window not appropriately sealed and not preventing moisture from entering window perimeter.
