BLM Companies LLC, Hurricane, UT

Audit Report Number: 2017-FW-1011

Date: August 29, 2017

BLM Companies LLC Failed To Ensure That It Protected and Preserved HUD Properties Under Its Field Service Manager Contract for Area 1D

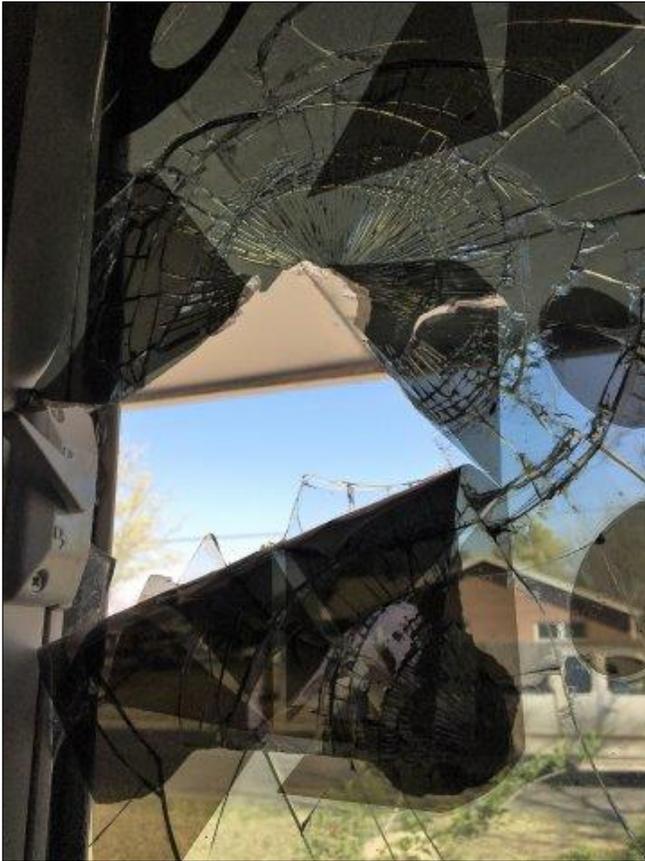
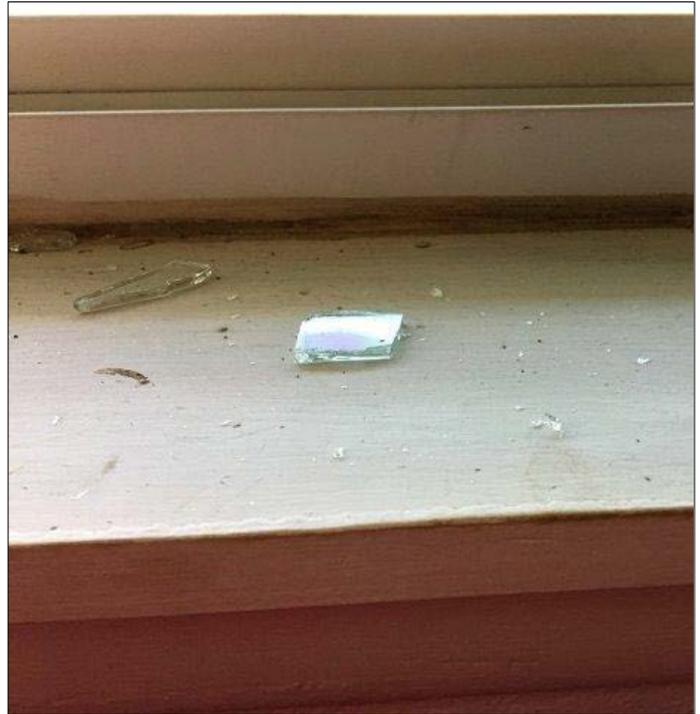
As an example, a sample property in Roswell, NM, had a broken window that BLM did not replace for more than 8 weeks. Further, it did not correct the health and safety hazard posed by the broken glass and exposure to the elements. BLM's inspector reported the broken window during three inspections (February 18 through March 20, 2017), and it appeared on the corresponding exception reports. According to BLM's work order history, it did not issue a work order to replace the window glass until March 11, 2017. The closed work order contained photographs, dated April 15, 2017, showing the replacement of the glass.

Audit photographs of the broken window and the glass on the windowsill on March 22, 2017

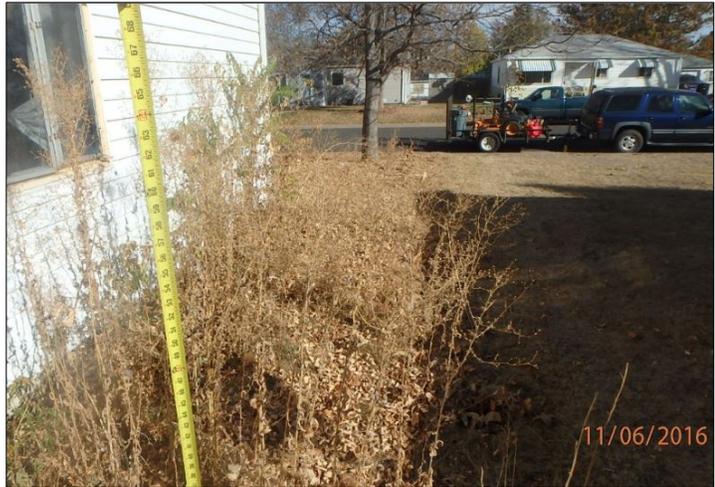
In another example, BLM's employee (also a quality control field inspector) conducted the initial inspection and yard care and health and safety services on a custodial property in Denver, CO, on October 13, 2016. The employee reported that mowing the yard and weeds would not be completed because of broken lawn equipment. BLM issued a work order on October 23, 2016, to a vendor to perform yard maintenance. On November 6, 2016, instead of cutting and removing the weeds, the vendor submitted photographs showing 2- to 6-foot tall weeds in different areas of the yard.

Lawn maintenance vendor's November 6, 2016 photograph

On November 5, 2016, BLM issued a work order to a different vendor to perform the work. On November 7, 2016, the vendor removed large amounts of leaves and cut down the overgrown grass and weeds, but deficiencies remained.⁶

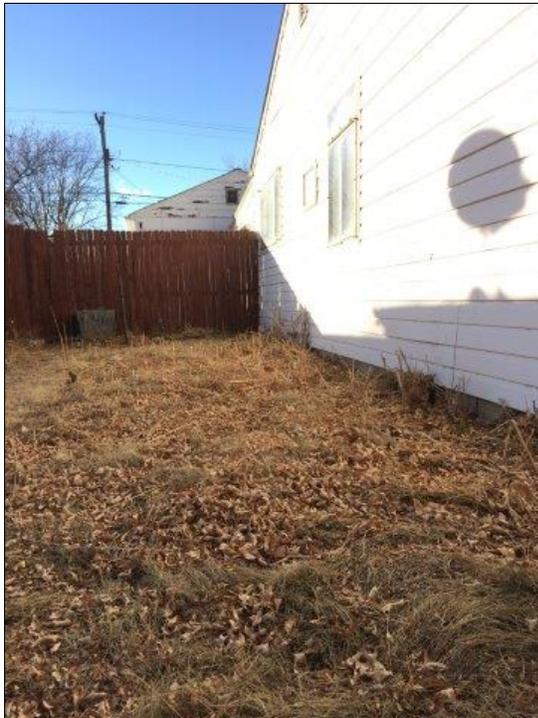
Auditor's December 5, 2016 photograph

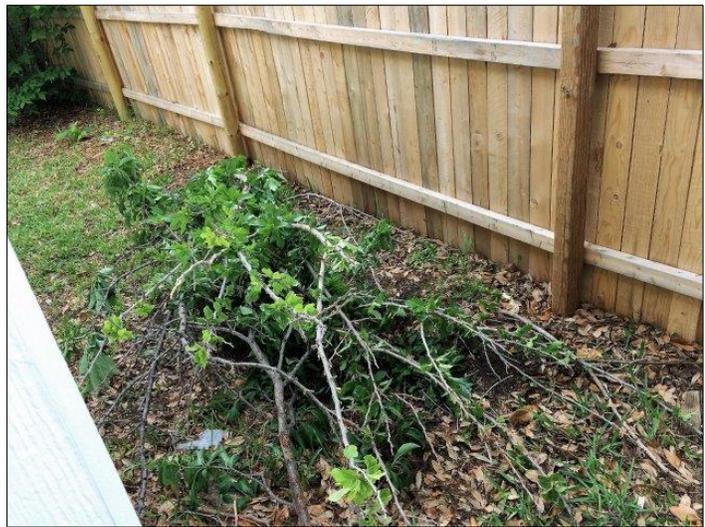
For instance, BLM issued work orders to address deficiencies communicated after our sample property observations. A return visit⁸ to a sample property in Fort Worth, TX, showed that a vendor had signed the sign-in sheet that day and written that he had performed an inspection and yard maintenance. During the return visit, the back door was unlocked, one window would not lock, tree limbs were still touching the house, gates were open, and there were cut tree limbs behind a shed in the backyard that the vendor should have removed. The vendor's photographs did not disclose these deficiencies.

April 20, 2017 photograph during return visit

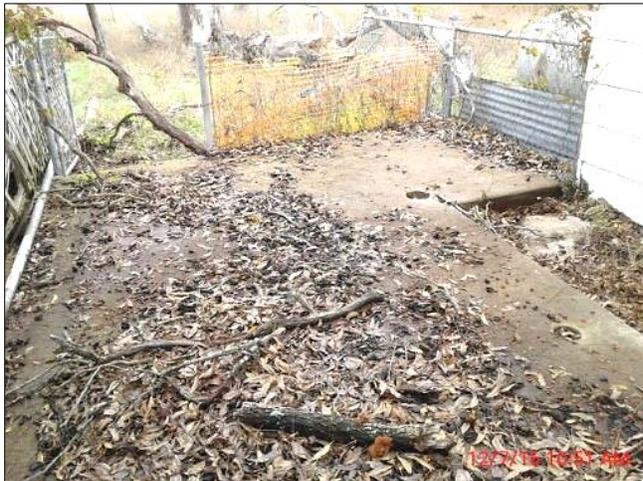
For example, a sample property in Gatesville, TX, had extensive exterior health and safety hazards, excessive accumulated leaves, fallen tree limbs on the house and in the yard, and several cracked windows. In addition, the access door to the basement was unsecured, and there was no evidence that it had ever been secured. On seven occasions between February 2016 and April 2017, BLM's exception reports showed that vendors or its own inspector reported fallen tree branches and debris in the yard or on the roof. BLM's field inspector conducted a quality control field inspection of the property on November 26, 2016. The closed work order contained only four images: a map showing the property address and three photographs showing the front of the home, the area under the carport, and leaves in the backyard. To illustrate the lack of followup to the inspections, the photographs below show what the BLM employee submitted during a December 7, 2016, routine inspection and a similar photograph during the March 8, 2017, OIG observation of the sample property. The photographs were taken from opposite angles, both showing a fallen tree limb against the porch surround.

Routine inspection on December 7, 2016

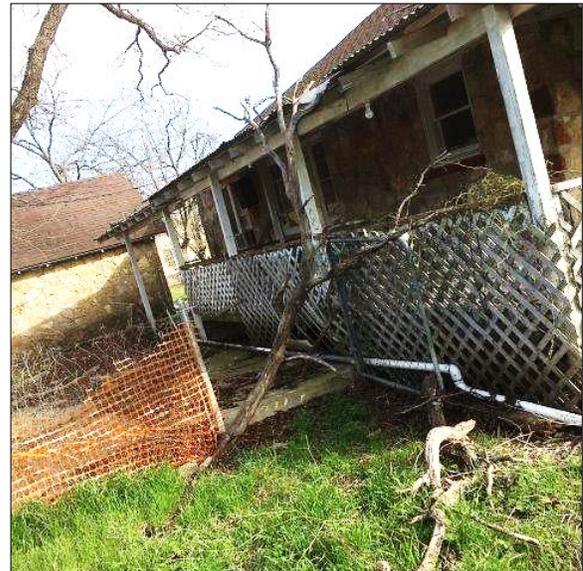
OIG observation on March 8, 2017
