BLM Companies LLC, Hurricane, UT

Single-Family Real Estate-Owned Management and Marketing III Program Field Service Area 4P

**Audit Report Number: 2017-CH-1011
September 30, 2017**

Subject: BLM Companies LLC, Hurricane, UT, Did Not Provide Property Preservation and Protection Services in Accordance With Its Contract With HUD and Its Own Requirements

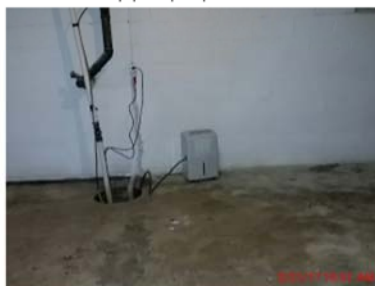
- 4.) [REDACTED] (FHA case number 412-656192)
 - 1c Promotion Date: 2/23/2017
 - OIG Inspection Date: 2/27/2017
 - Current Step: 8-Sales Offer
 - Days in Inventory: 123 Days
 - Vendor still being utilized: Yes
 - Deficiencies Noted:
 - Water in basement
 - BLM Response: Water not present upon 1c promotion. BLM has been addressing issue continuously throughout life of property. Property has wet basement as sump pump is present.

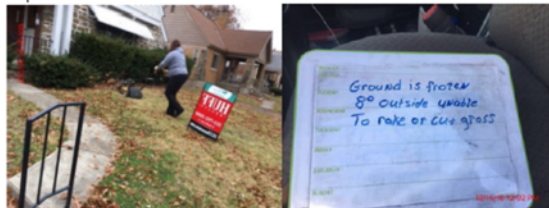
- **[REDACTED] (FHA case number 411-423079)**
 - **OIG Inspection Date: 12/16/2016**
 - Property was undergoing Lead Based Paint Stabilization, entering property could have caused dust to move and cause LBP Clearance to fail. This would increase HUD's holding time and cost of this property.
 - Landscape issue – leaves and debris in the yard
 - Leaves covered the front and back yards of the property. The rear door to the basement, which is below ground level, had a pile of leaves in front of the door. Debris such as mail, a garbage bag, and rotted plywood were scattered in the yard and driveway.
 - BLM Response: Leaves were frozen to ground on previous yard maintenance. BLM recognizes that small debris can blow onto the properties at any time. Vendors are reminded to always remove and dispose of such debris.

- Unmarked trip hazards
 - Flooring between the kitchen and dining room is elevated and not marked. A bedroom is missing a piece of hardwood flooring, and it is unmarked. Chipped tiles are unmarked. There was exposed carpeting tack strips in an upstairs bedroom.
 - BLM Response: BLM is not permitted to enter the property during this period to address any issues due to the stabilization signage.
